# Important Safety Recall

## DEWALT Framing Nailers

**DEWALT D51844 and D51845 Heavy-Duty 20° Full Round Head Framing Nailer**

**DEWALT D51822 Heavy-Duty 31° Clipped Head Framing Nailer**

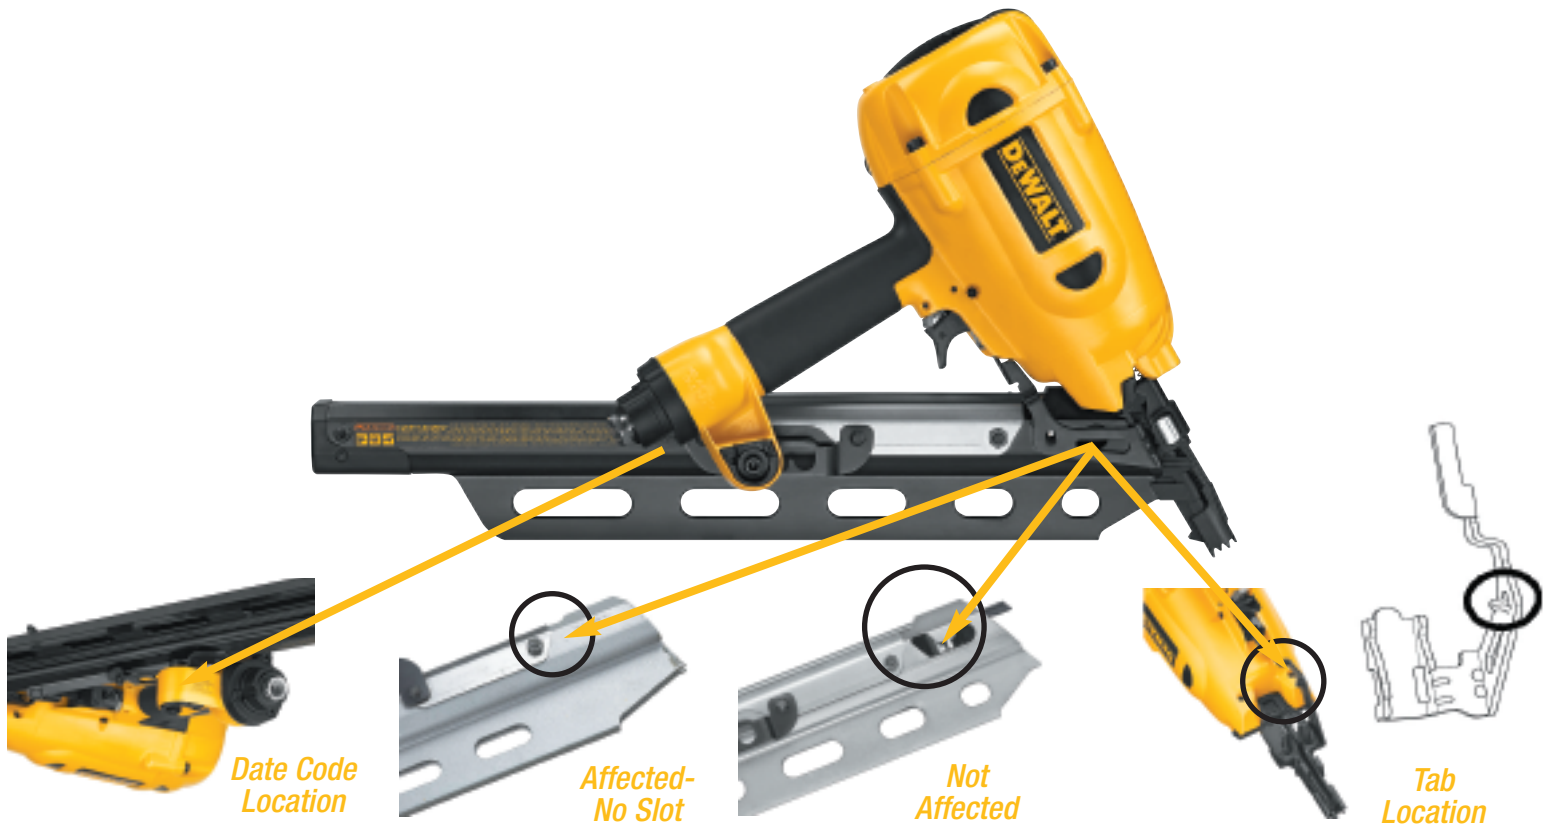
The contact trip on some of the nailers may not operate properly, which may permit a nail to be ejected with only trigger actuation.

Check the top right side of your magazine to determine if it is missing the slot as shown in the images above

Check to see if the tab shown in the drawing at right is present on the contact trip. If yes, follow directions below.

If your nailer is affected, **STOP USING IT IMMEDIATELY**, and call DEWALT toll free at  
**1-866-397-3228**

between 8:00 a.m. and 4:30 p.m., Eastern Time, Monday through Friday,  
or at [www.DEWALT.com](http://www.DEWALT.com) for the location of a service center  
to obtain a free inspection and repair, if necessary.
